NASA Contractor Report 158969

**ASSESSMENT OF STATE-OF-THE-ART
OF IN-SERVICE INSPECTION METHODS
FOR GRAPHITE EPOXY COMPOSITE
STRUCTURES ON COMMERCIAL
TRANSPORT AIRCRAFT**

**Boeing Commercial Airplane Company
Seattle, Washington**

**Contract NAS 1-15304
January 1979**

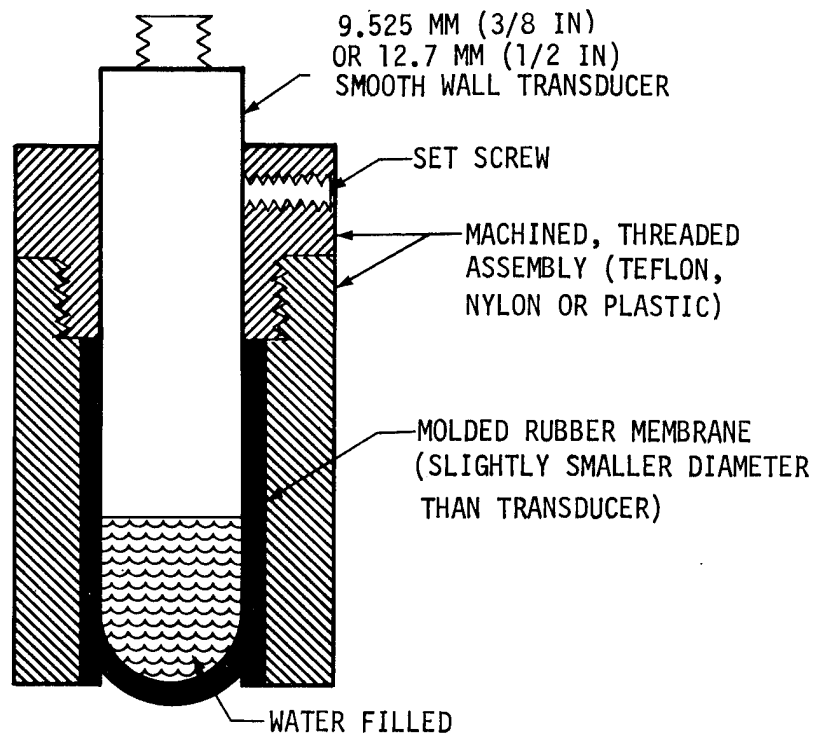
FIGURE 1. STAND-OFF SEARCH UNIT

- o Standard ultrasonic test instrument equipped with a high-resolution pulser-receiver unit for 5, 10, and 15 MHz transducers.
- o One each 5, 10, and 15 MHz high-resolution contact search units.
- o One each 5, 10, and 15 MHz transducers adaptable to angle beam shoes.
- o Angle beam shoes.
- o Couplant: oil, grease, commercial couplant. Also, water bubblers, squirters, and encapsulated water standoffs have been used. The latter is illustrated in figure 1.

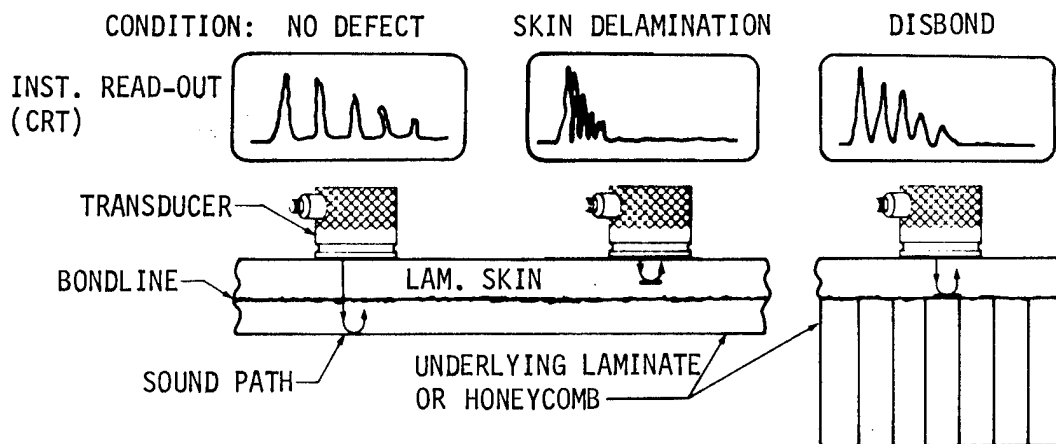
FIGURE 2. STRAIGHT BEAM TECHNIQUE

Two methods are described--the straight beam method and the angle beam method. Both are effective in detecting delaminations in the laminated composite skin and delaminations or disbonds at the skin-to-underlying structure interface. The angle beam method is applicable only to metal honeycomb. (It is unlikely that nonmetallic honeycomb will support sufficient sound transmission levels.) The straight beam method is applicable both to skin-to-honeycomb and skin-to-underlying laminate bonds. The two methods are illustrated in figures 2 and 3.

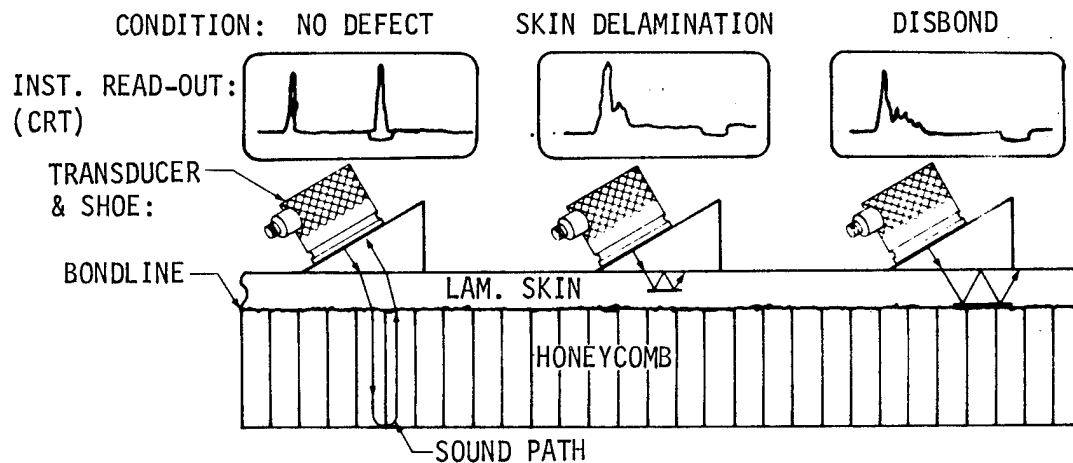
FIGURE 3. ANGLE BEAM TECHNIQUE

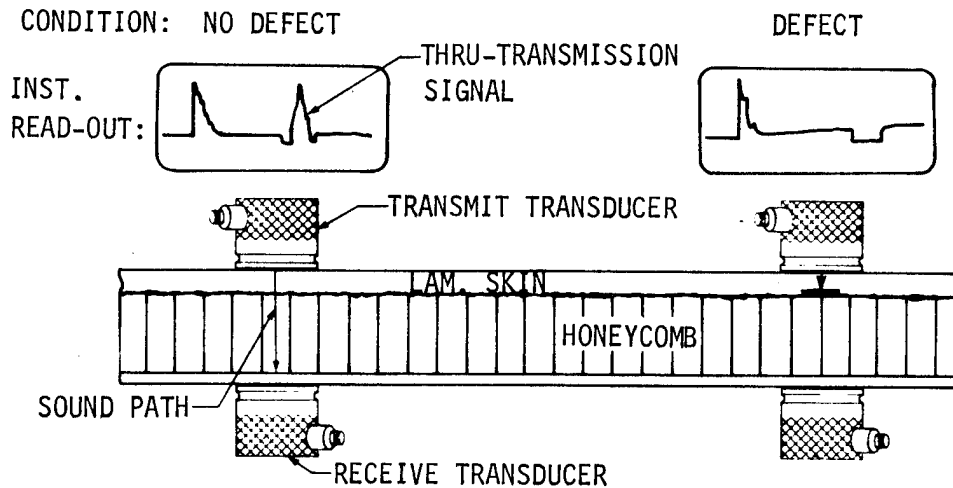
FIGURE 4. THRU-TRANSMISSION TECHNIQUE

One of these is to manually place one of the transducers in direct contact with the part (using a couplant) and position the other transducer over the opposite surface to obtain a maximum through-transmission signal. This is repeated until the area of interest has been covered. The other method uses a yoke assembly to hold both transducers in constant alignment while scanning the transducers over the area of interest. These methods have been used to inspect limited areas of a given part.

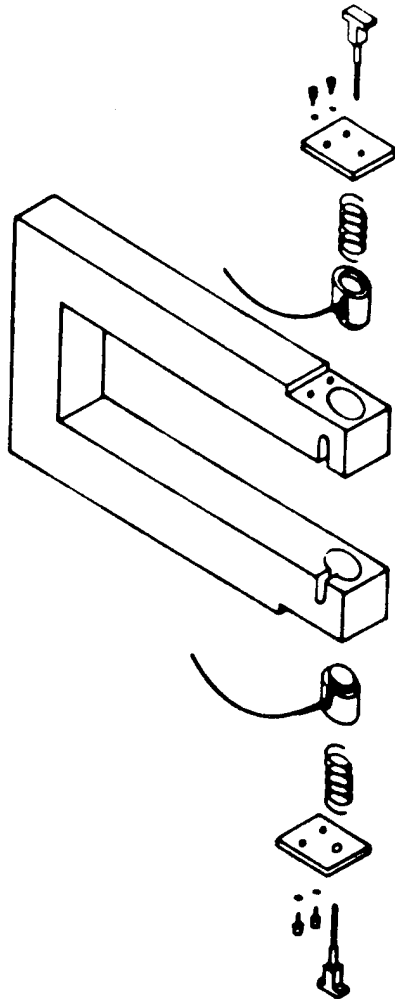
FIGURE 5. YOKE FOR THRU-TRANSMISSION INSPECTION * *(FROM "S-3A GRAPHITE/EPOXY SPOILER DEVELOPMENT PROGRAM, VOL II" JULY 1975, E.G.BLOSSER, ET AL.)

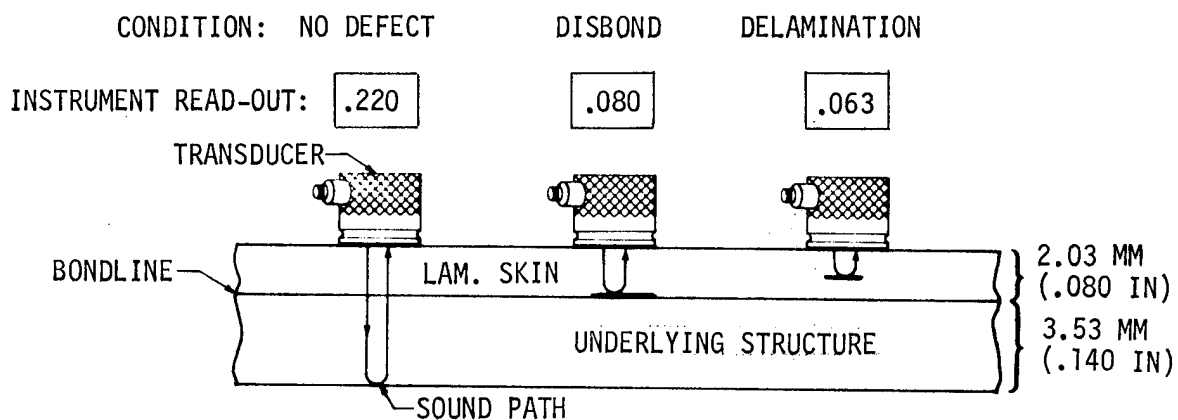
FIGURE 6. DIGITAL THICKNESS GAGE METHOD

This method uses the pulse-echo principle wherein a transducer in contact, through a couplant, with the part surface generates a pulse that travels to the opposite surface of the laminated skin, echoes from this surface, and returns to the transducer. The time interval from pulse initiation to its return to the transducer is measured electronically and presented as the part thickness on a digital readout. This method detects delaminations in a laminate and may detect disbonds if the skin-to-underlying structure bond permits the pulse to pass into the underlying structure. It is illustrated in figure 6.

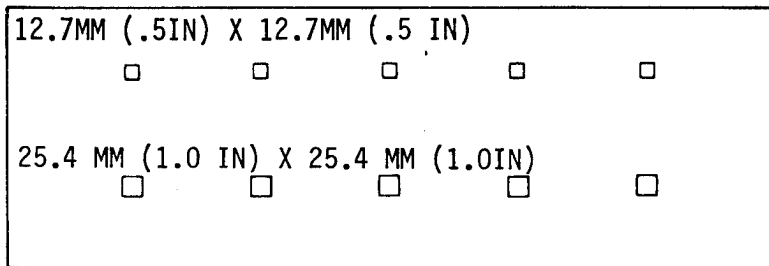
- 10 PLY LAMINATE
- GRAPHITE-EPOXY TAPE
- 2 MIL TEFLON (2 EA)
BETWEEN NO. 1-2, 2-3,
3-4, 4-5, 5-6 PLYS
- SPACING: 38.1MM (1.5 IN)
EDGE MARGIN & BETWEEN
DEFECTS

FIGURE 7. TYPICAL GRAPHITE-EPOXY DELAMINATION AND DISBOND REFERENCE STANDARD

These are suitable for standardization of ultrasonic pulse-echo and through-transmission, bond test, and validation of tap test methods. They are fabricated by placing Teflon tape, mylar-covered porous filter material, Tedlar, precured adhesive, or prepreg tape in the bondline and between plies of a laminated part. The size is determined by the defect allowables criteria and shape may be either round or square. Figure 7 is typical. Step wedge thickness standards are illustrated in figure 8.

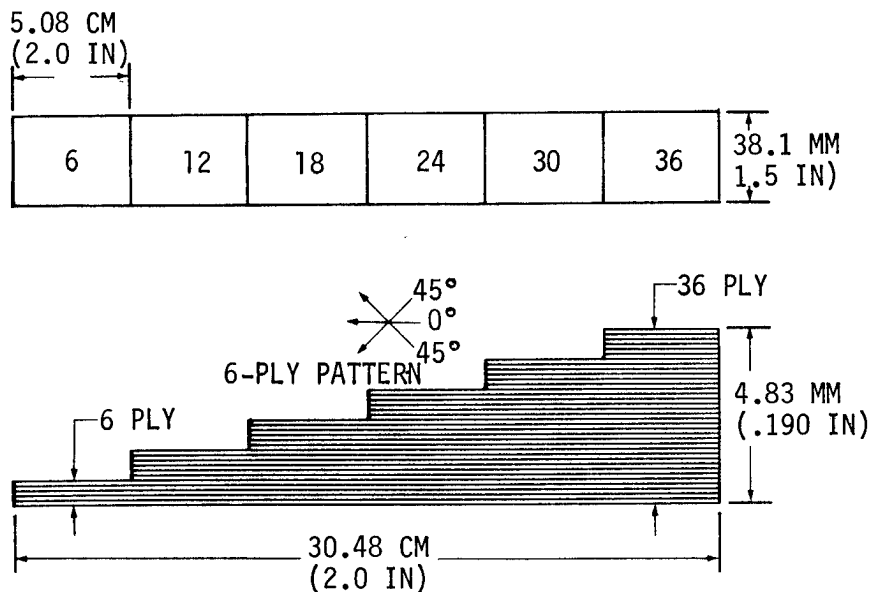
FIGURE 8. STEP-WEDGE THICKNESS REFERENCE STANDARD

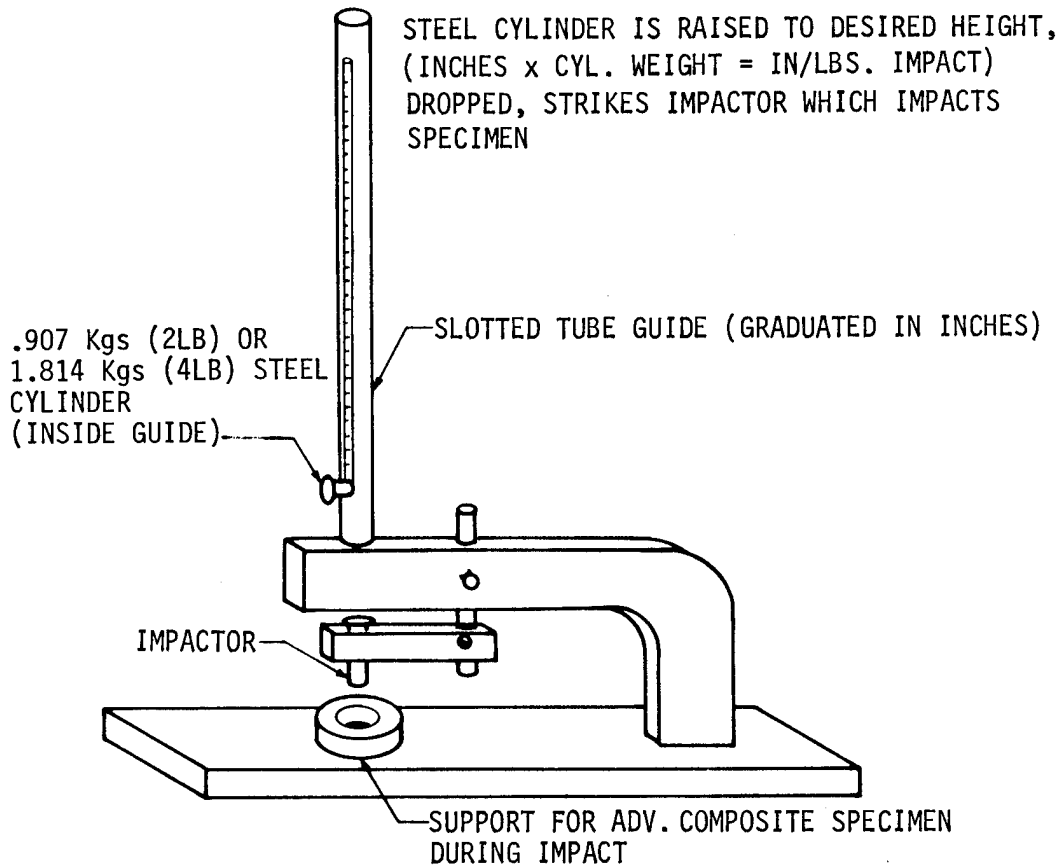
FIGURE 9. METHOD TO ACCOMPLISH CONTROLLED IMPACT DAMAGE

Impact Damage: This is created in the laminated skin member by impact of a blunt object with the test standard surface. A typical method is illustrated in figure 9. Impact defects in the reference specimen should range in severity up to visible damage. The nonvisible defects are used to verify sensitivity of ultrasonic, bond tester, and tap test methods.
